LAKE NAOMI DAM

PHASE I INSPECTION REPORT NATIONAL DAM INSPECTION PROGRAM

JULY 1979

LAKE NAOMI DAM
MONROE COUNTY, PENNSYLVANIA

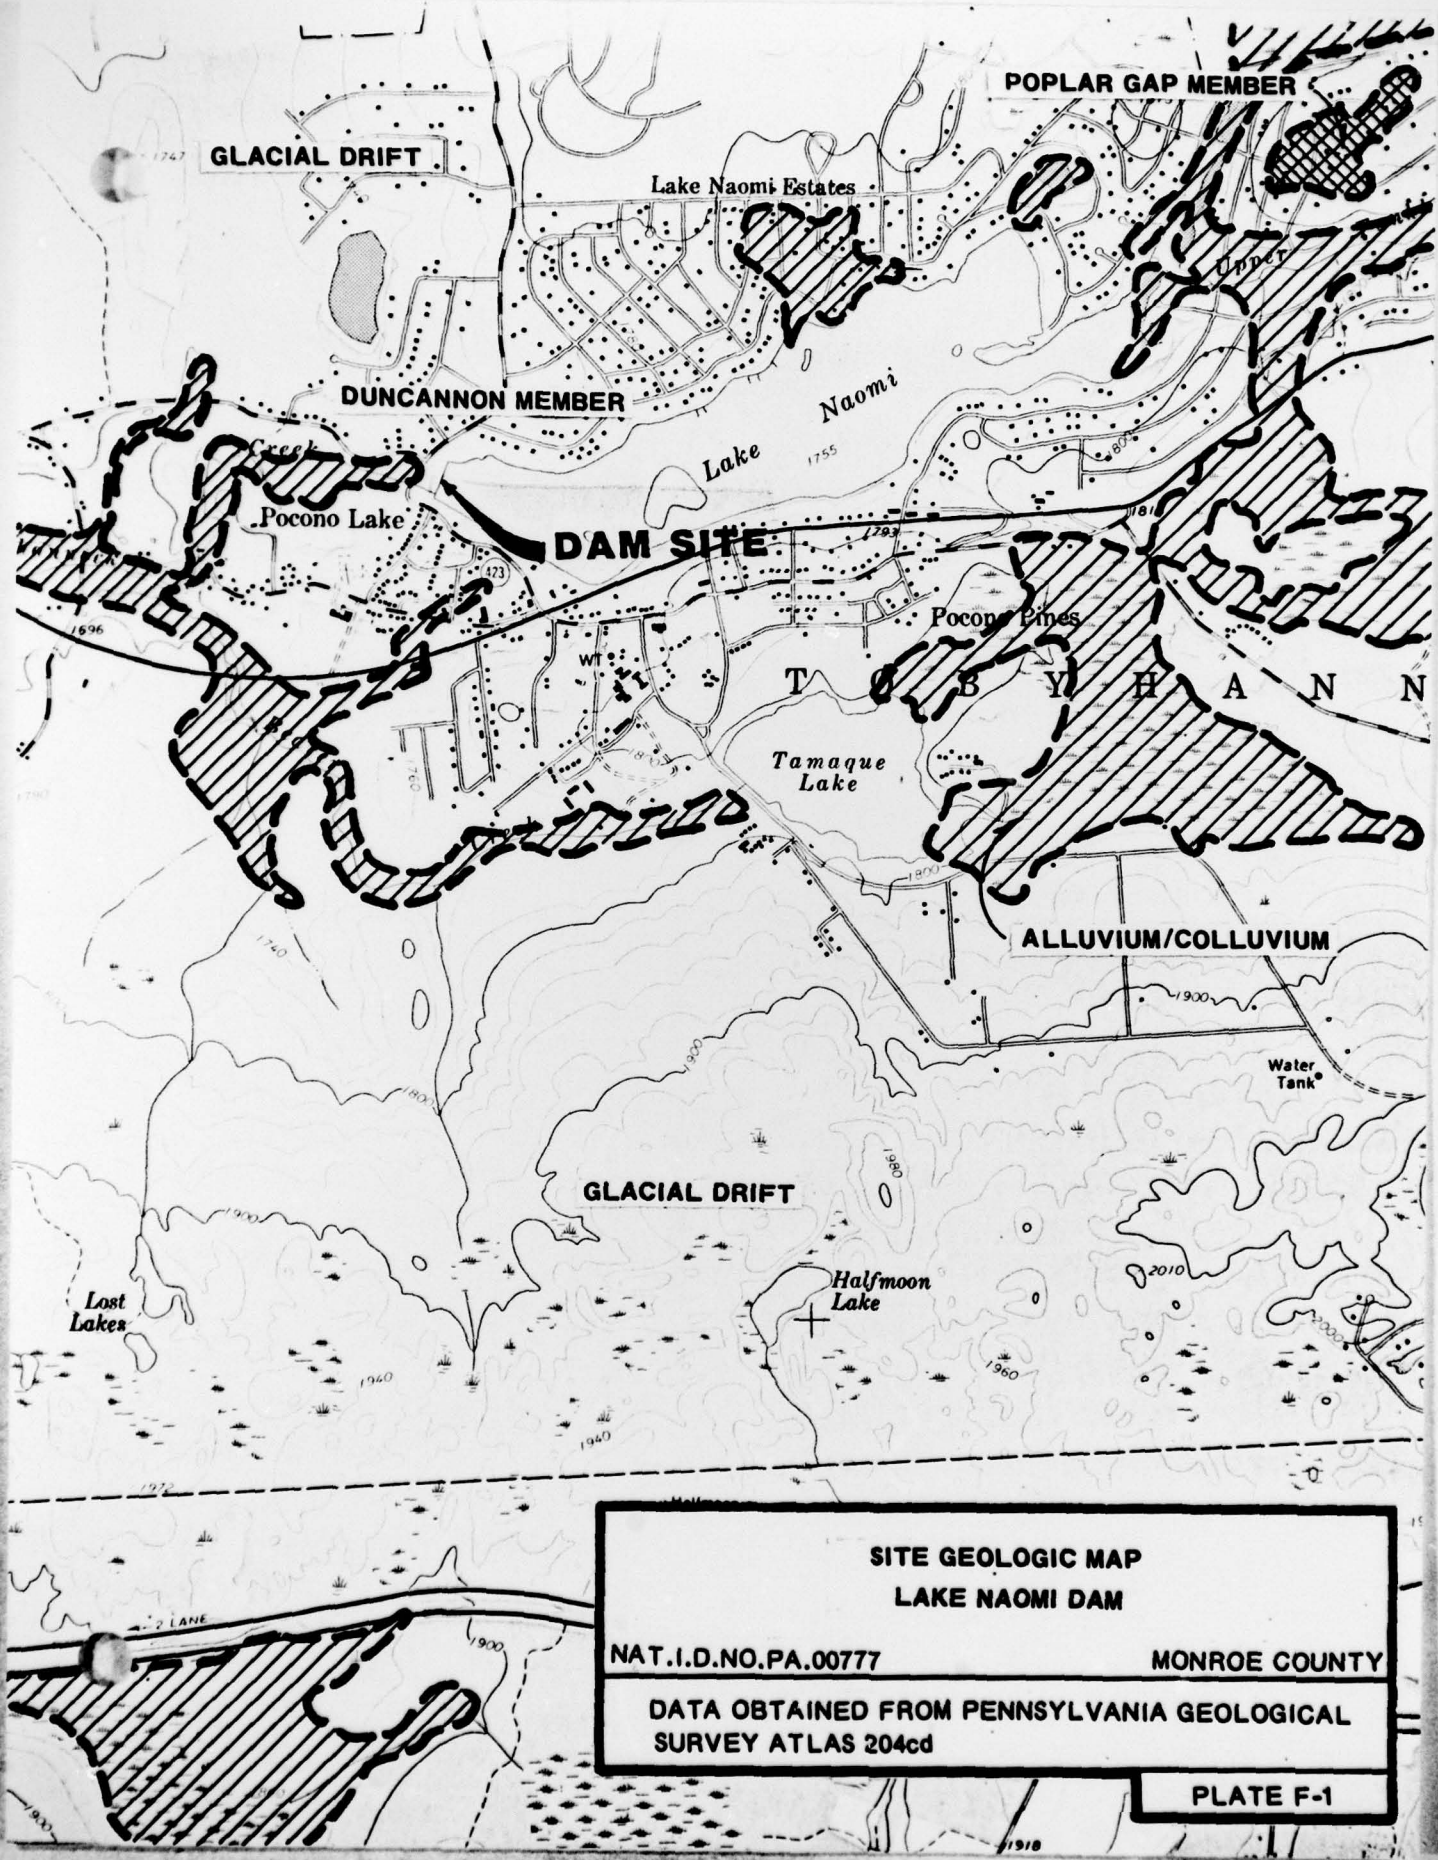
Lake Naomi Dam is located in the Pocono Plateau Section of the Appalachian Plateaus Physiographic Province. As shown on Plate F-1, the dam site and surrounding region, as is much of northeastern Pennsylvania, are overlain by a partial mantle of Wisconsin age glacial drift, having localized deposits of alluvium and colluvium. The bedrock in the site region belongs to the Upper Devonian age Catskill Formation. The sandstone beds of the Duncannon Member are exposed immediately downstream from the dam. Rock bedding strikes to the northeast and dips nine degrees to the northwest (approximately downstream). Two sets of rock joints are well developed. One joint set strikes east-northeast and the other strikes north-northwest. Both joint sets have near vertical dips. This has resulted in an overall blocky form to the rock outcrops.

The downstream direction of bedding dip, joint pattern and shallow depth to rock are conditions which could contribute to the seepage observed during the field inspection.
